**Riverbank Stabilization Project, 216 River Street,
Haverhill, Massachusetts**

PRESENTED TO CITY OF HAVERHILL CONSERVATION COMMISSION

Geosyntec
consultants

November 18, 2021

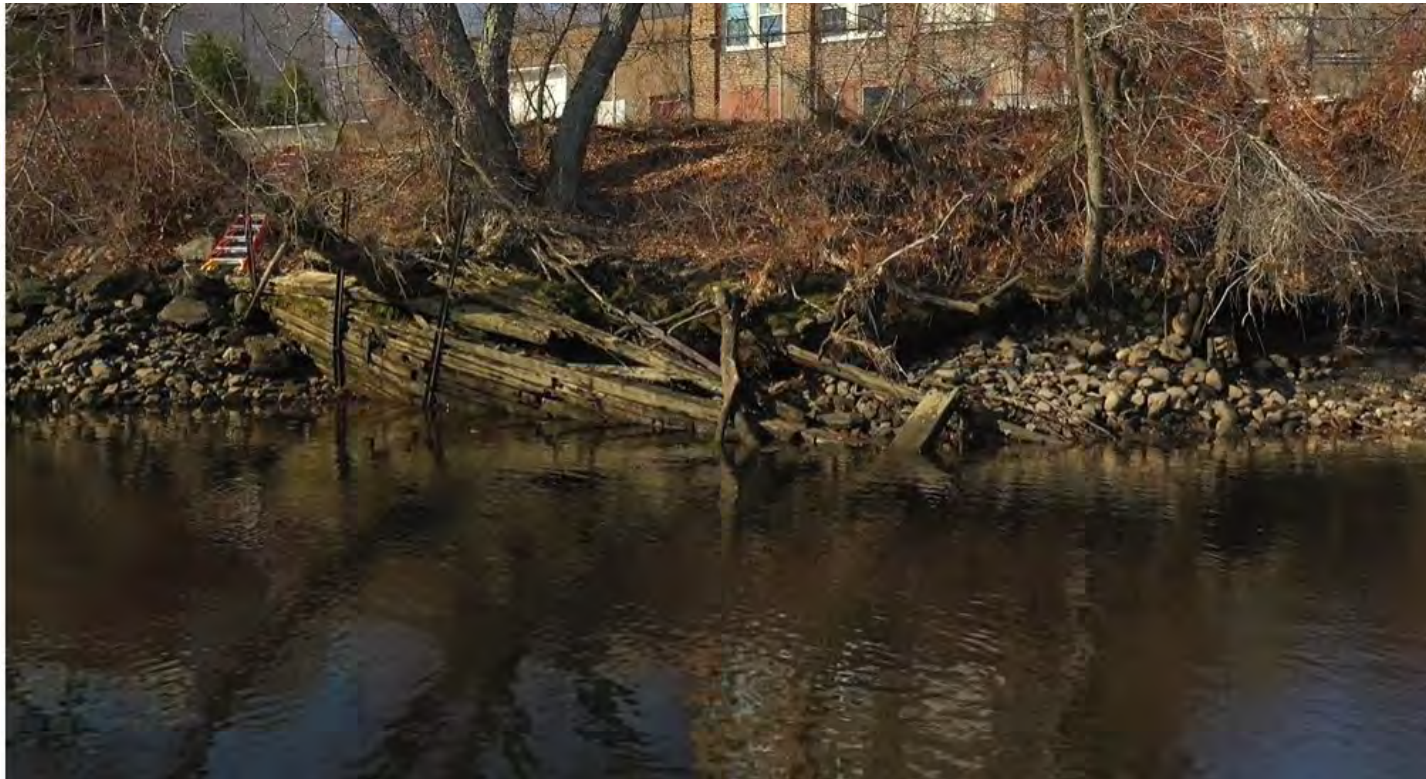
- Primary purpose of this project is to mitigate current erosion and to stabilize an eroded section of the north bank of the Merrimack River at the Site.
- The bank is severely eroded due to scour likely caused by ice and high flows during storm conditions and exacerbated by recent barge traffic associated with the Comeau Bridge construction project.
- The bank at 216 includes a wood structure similar to a bulkhead that has become undermined and has degraded (shown below).
